An Examination of the Summerhaven, Arizona Home Destruction Related to the Local Wildland Fire Behavior during the June 2003 Aspen Fire

Jack D. Cohen
Research Physical Scientist
USDA Forest Service
Rocky Mountain Research Station
Missoula Fire Sciences Laboratory
406-329-4821 jcohen@fs.fed.us

August 1, 2003

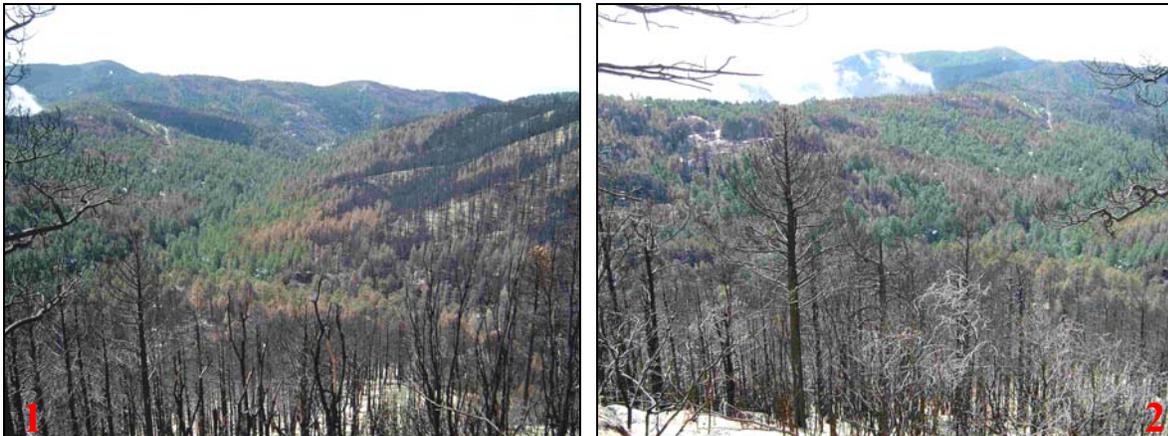
Photos 1,2—active spreading crown fire occurred above and to the west of Summerhaven but did not spread into the residential area.

The Aspen Fire started on June 17, 2003 in the Santa Catalina Mountains north of Tucson, Arizona. On June 19 the fire spread into the mountain community of Summerhaven. Over 300 homes and cabins burned in association with the wildfire. Photos 1 and 2 show the character of the wildfire. Crown fire occurred in limited patches and on the slopes to the west and above the residential area.

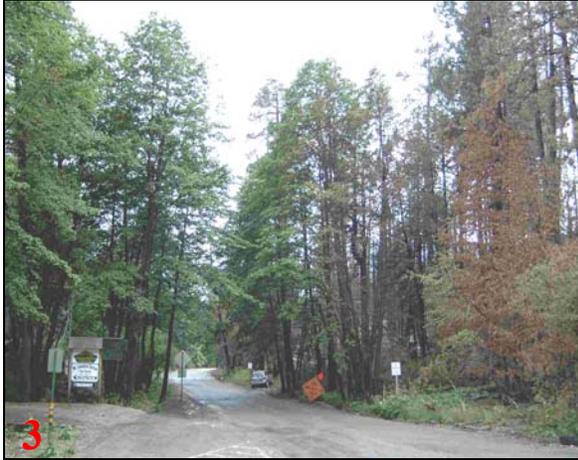
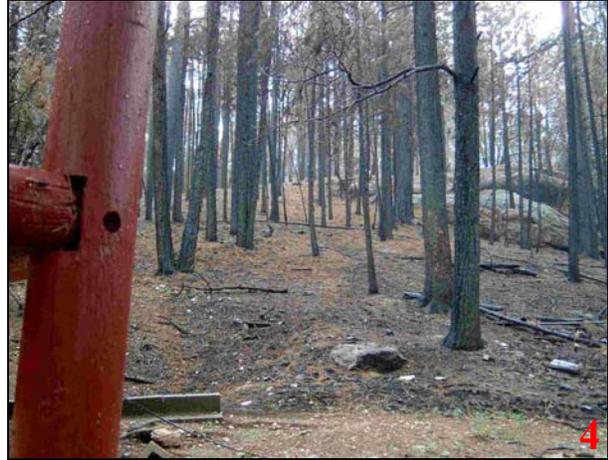
Photos 3,4—surface fire spread principally occurred within the Summerhaven residential area without burning in the tree canopies (crown fire).

High intensity crown fire spread did not occur in the bottom of the main gulch where Summerhaven resides. Photo 3 shows the post burn situation along the main road down slope and up-wind from structure locations. Photo 4 shows surface fire spread that was typical under the conifer canopy. Although the surface fire spread does not produce high intensity burning, the intensities and durations produced significant canopy needle kill.

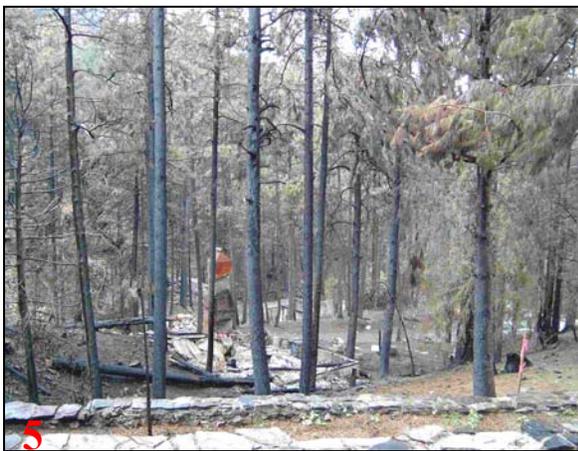
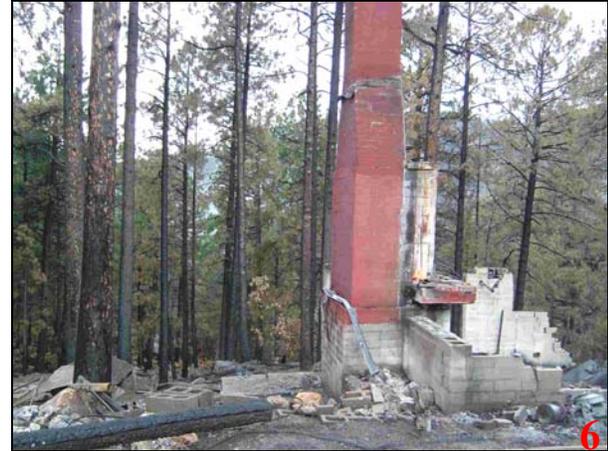
Photo 5,6—totally destroyed homes surrounded by unconsumed tree canopies indicate that lower intensity surface fires burned in the structures' surrounding areas.

The surface fire spread does not produce direct flame heating sufficient to ignite the wood exteriors of structures beyond about 10-15 feet. Photos 5-9 provide examples from various locations within Summerhaven that represent the destruction of the entire area.

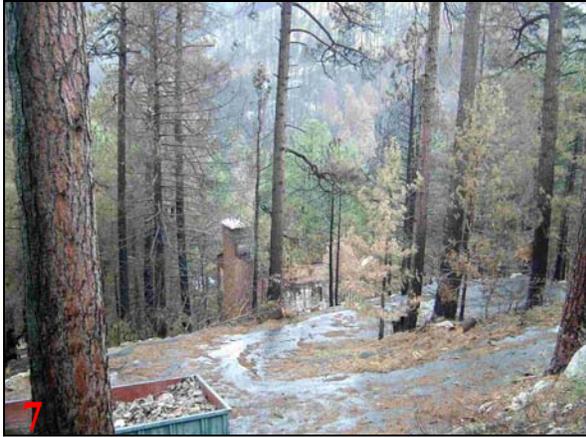
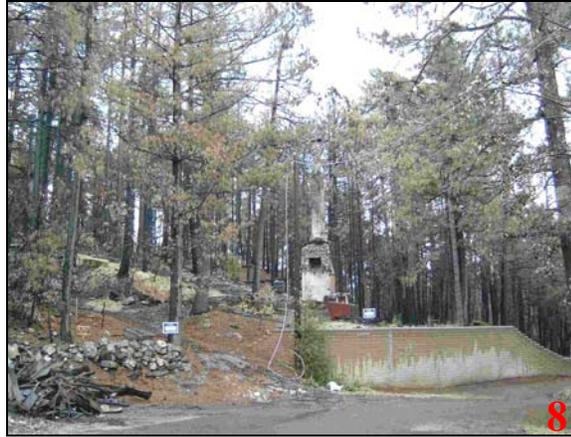
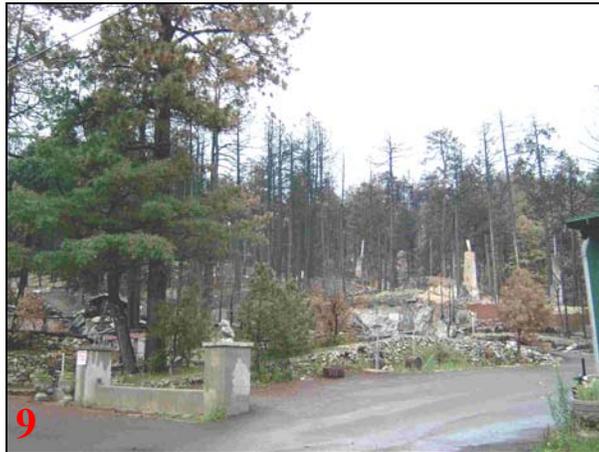
Photos 7,8,9—totally destroyed homes surrounded by unconsumed tree canopies indicate that lower intensity surface fires spread to the structures' surrounding areas.

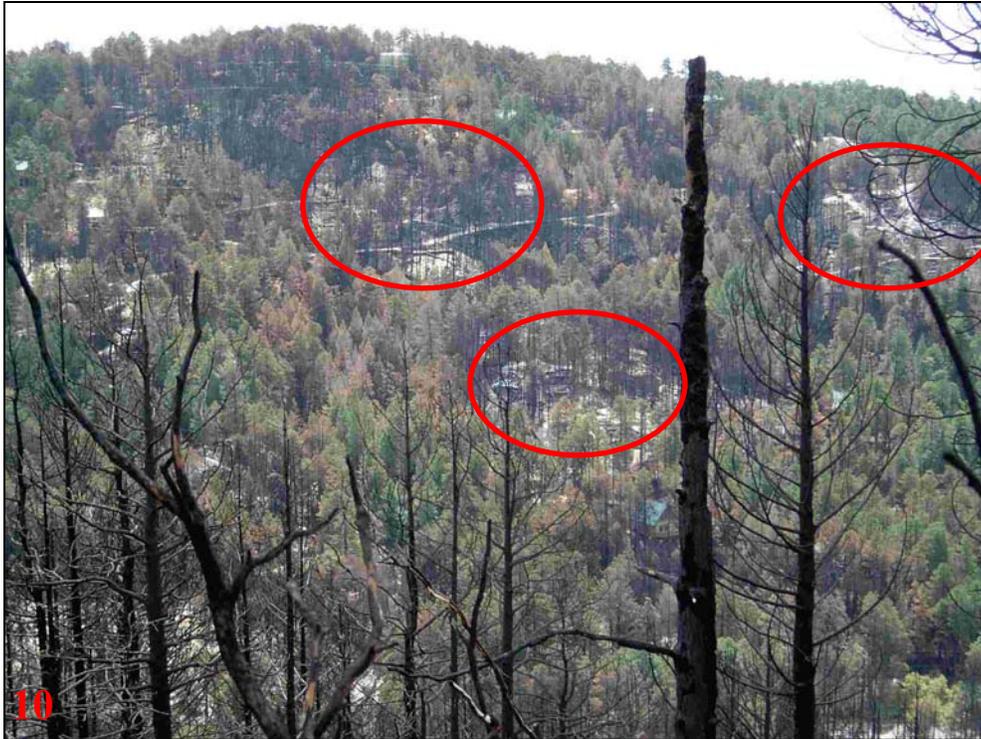
Photo 10—patches of burned trees that are associated with multiple totally destroyed homes break the largely unconsumed forest canopy. The red ovals show 3 examples of this burn pattern.

The evidence indicates that burning homes commonly burned the adjacent and overhanging trees. Tree canopy burning began at totally destroyed structures. In several areas of higher structure density, the evidence suggests that burning homes ignited the tree canopy that subsequently carried into adjacent structures. As each structure ignited more canopy ignited. The hillside burn pattern indicates that the ignited tree crowns originated at burning home locations. Photo 10 shows the patched pattern of destroyed homes and associated burned trees surrounded by unconsumed tree canopy. The crown fire originates and ends in association with home destruction. Photos 11-12 show the home destruction and canopy consumption within such a patch. Photos 13-14 show evidence of decreasing consumption and the charring of tree trunks and canopies as the distance away from a structure increases. Note the mottled char pattern on the tree trunks. The mottled portion is where all bark was consumed facing the burning house. The side away is charred but bark remains. Without examining the large scale patterns of home destruction associated with tree crowning and the small scale patterns of consumption, one might get the impression that the high intensity crown fire spread into the residential area and caused the destruction rather than the likely sequence of a home or homes burning leading to tree canopy fire involvement.

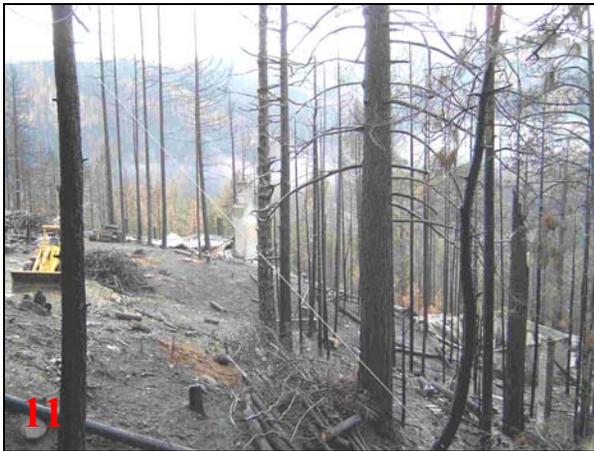
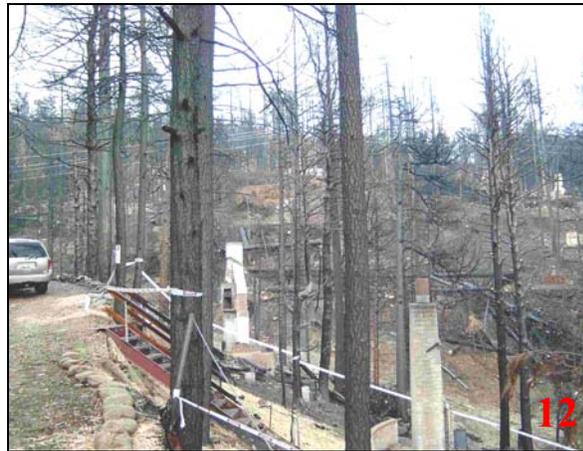
Photos 11,12—burning homes commonly burn the trees in close proximity. Where homes are close together, the trees burn around and between the homes producing areas of totally destroyed homes and associated burned tree canopies. Note the multiple homes present in each photo.

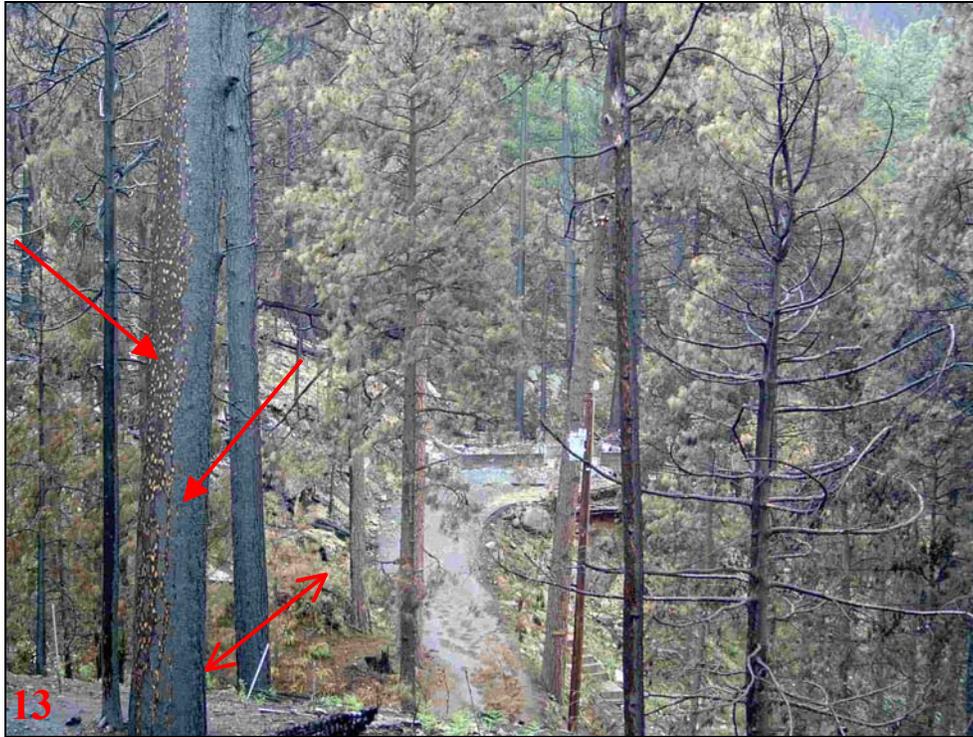
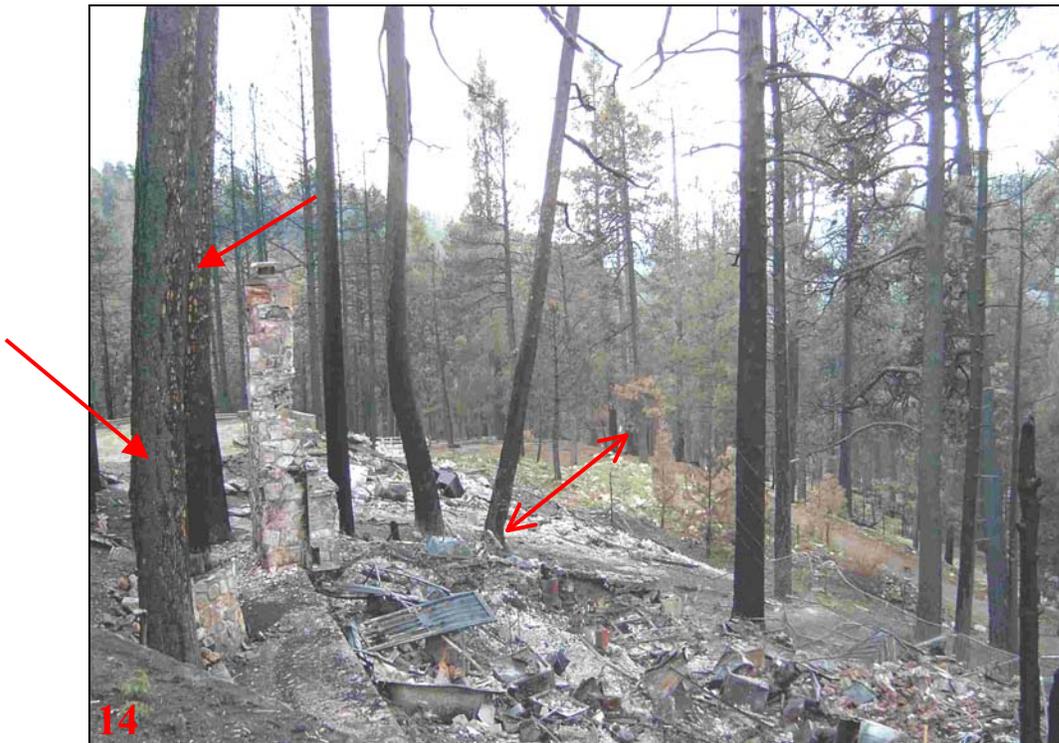
Photos 13,14—the red arrows indicate the complete bark consumption (mottled) on the side facing the burned home and char with remaining bark on the side facing away. The double ended arrow indicates the decreasing consumption and char as the distance from the burned home increases.

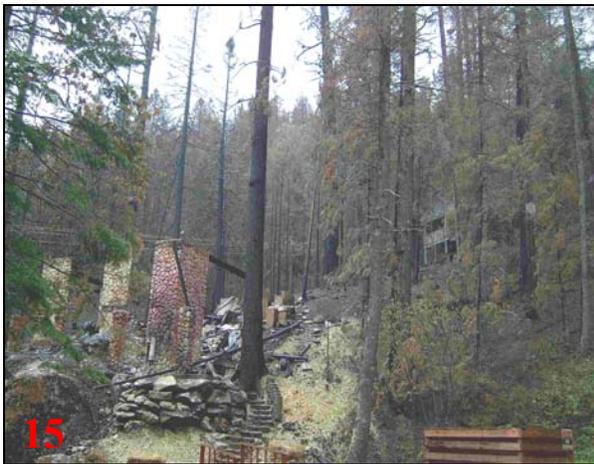
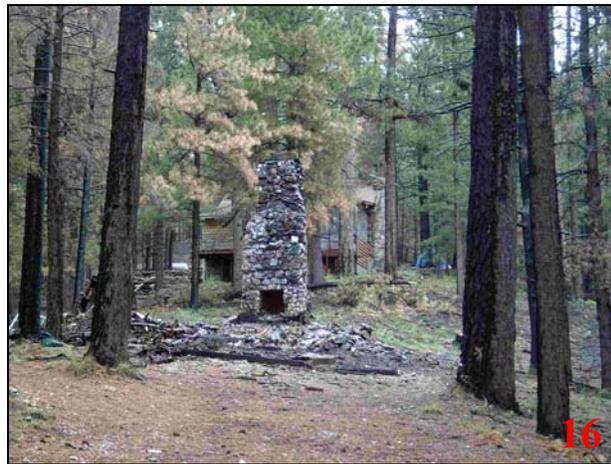
Photos 15,16—homes destroyed adjacent to homes survived indicates that significant differences existed in the fire and home characteristics necessary to meet the requirements for home ignition.

That leaves the question of how one home can survive adjacent to total home destruction. Photos 15-16 show such a situation. Fire does not behave capriciously; it either meets the requirements for combustion or not. If a high intensity crown fire had spread through the entire residential area then the distances between structures would not have made significant differences in the requirements for combustion. But even crown fires do not have the ability to directly ignite wood at distances greater than 100 feet. Thus, when surface fire principally occurs, the ability to directly ignite a home must occur within a few feet of or in contact with the flammable parts of the structure. A structure may ignite directly from firebrands that have come from an intense wildland fire at over ½ mile away, but these ignitions are dependent on the materials and design of the structure. Thus, significant differences in the requirements for combustion can occur from one house to an adjacent house. These differences in the direct flame and firebrand exposures related to the home characteristics result in one house surviving next to its destroyed neighbor.
